Manhole Inspection Summary

Manhole # S55K__038MH

Insp Date: **3/4/09 11:10 AM**

Location Address: **rear 627 s eaton st**

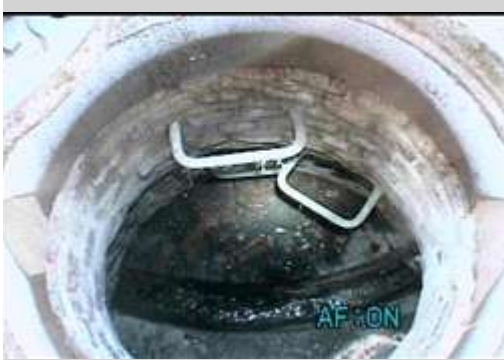
Defect 1

Steps Count: **3** Missing: **0** ☒ **Corroded**

corr steps

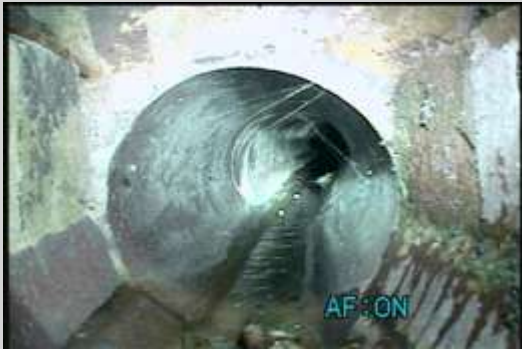
12 O'Clock Outflow

8 in. Circular Gravity Sewer
Pipe Out @ 12 O'Clock

Pipe Material: **Clay** ☐ Pipe Lined

Invert Depth: 6.33 (ft.) Flow Characteristics: **None**

Infiltration: **None** Pipe Seal Cond: **Unknown**

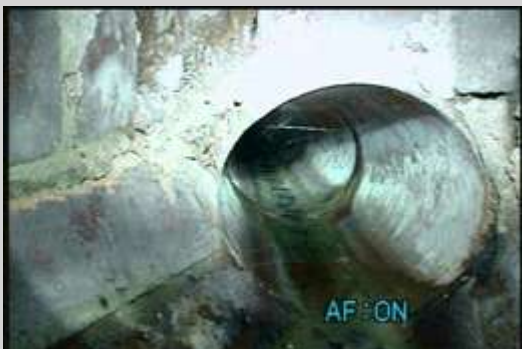
5 O'Clock Inflow

8 in. Circular Gravity Sewer
Pipe In @ 5 O'Clock

Pipe Material: **Clay** ☐ Pipe Lined

Invert Depth: 6.16 (ft.) Flow Characteristics: **None**

Infiltration: **None** Pipe Seal Cond: **Unknown**
